NOTICE TO MARINERS

No. H. 24/2021

RIVER OUSE

GOOLE DOCKS – SOUTH DOCK SUBMERGED
OBSTRUCTIONS

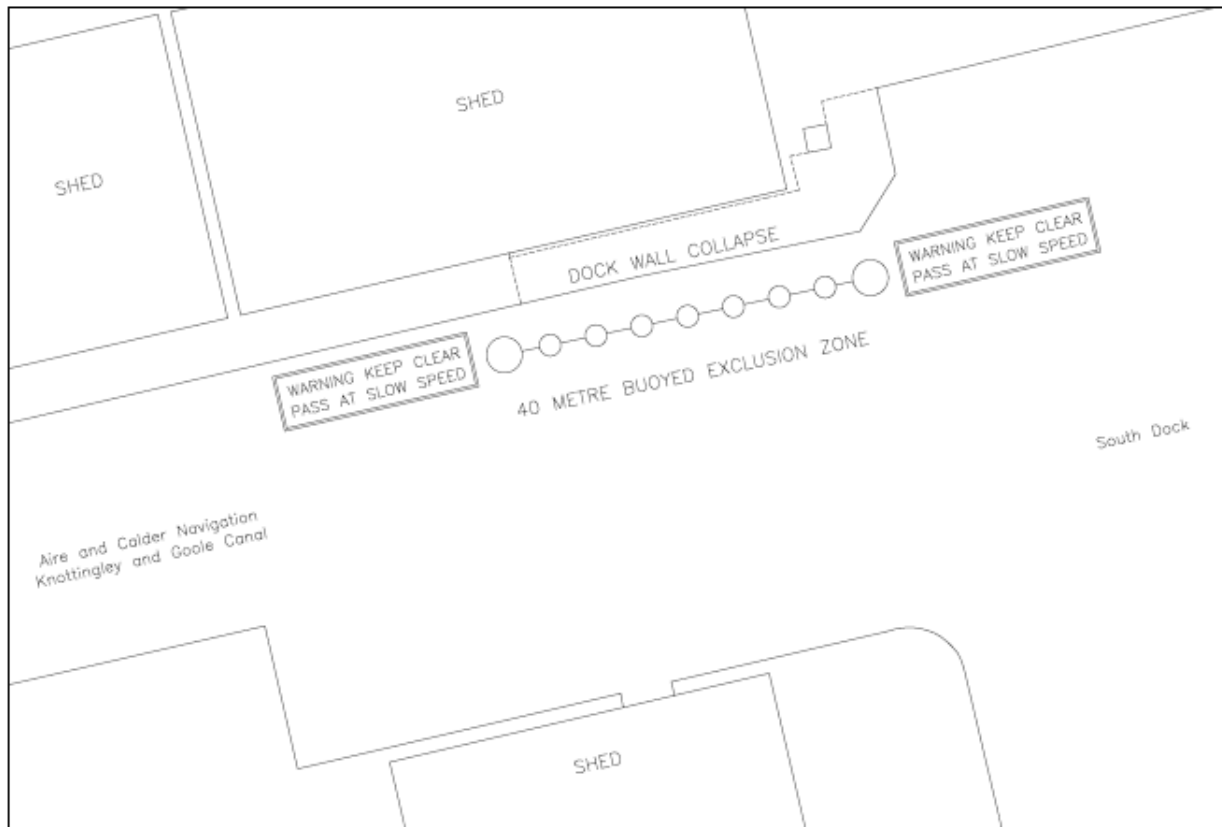
MARINERS ARE WARNED that submerged and partially submerged obstructions exist as the result of a recently collapsed dock wall in South Dock, Goole. The area of obstruction extends out into the dock approximately five metres from the original wall face for a length of 40 metres.

The obstruction consists of large baulks of timber protruding vertically from the riverbed, which were previously the foundations of the wall, and as such could pose a significant hazard to any vessel navigating in the area. The obstructions will be marked as soon as possible with yellow unlit buoys.

MARINERS ARE REQUESTED to remain to the south of the dock wall and marker buoys (once in position) and to pass the area at slow speed giving a wide berth.

MARINERS ARE ADVISED that works to repair the wall and remove the obstructions will be carried out as soon as is practicable.
